# **Rochester Intermodal Station Project**

## **PIN 4936.04**

### **Evaluation of the 1914 Pedestrian and Baggage Subway Tunnel under CSX Running Tracks**

April 2012

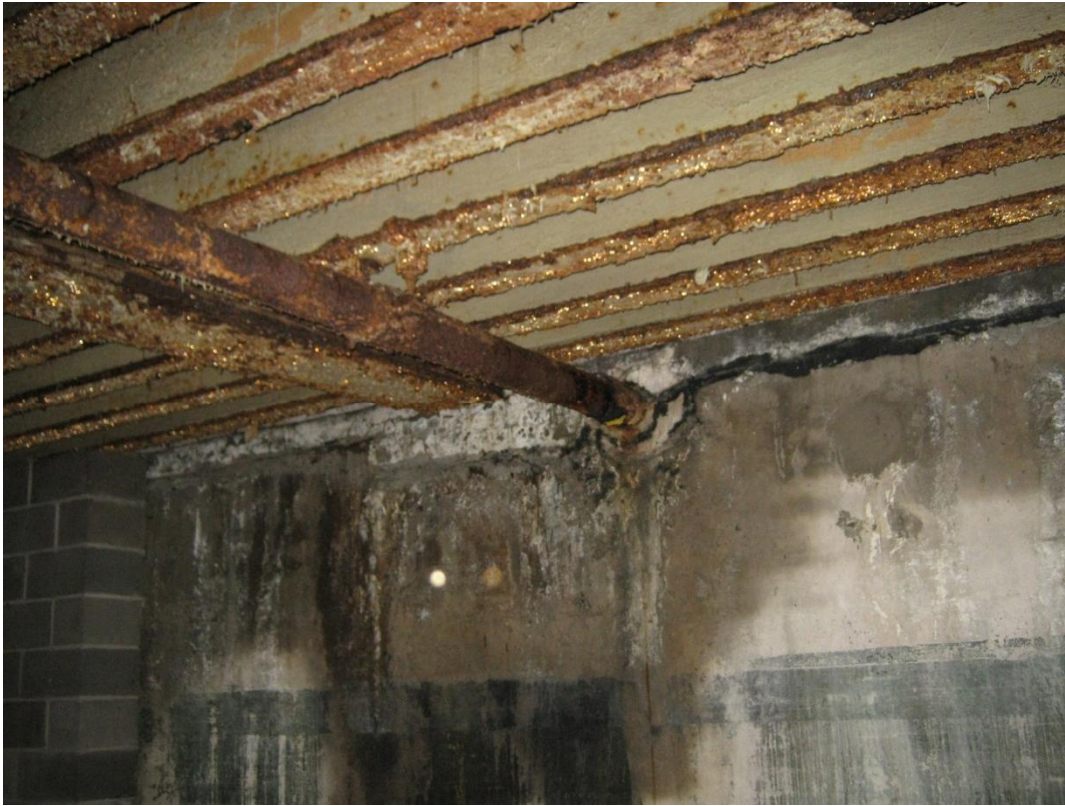
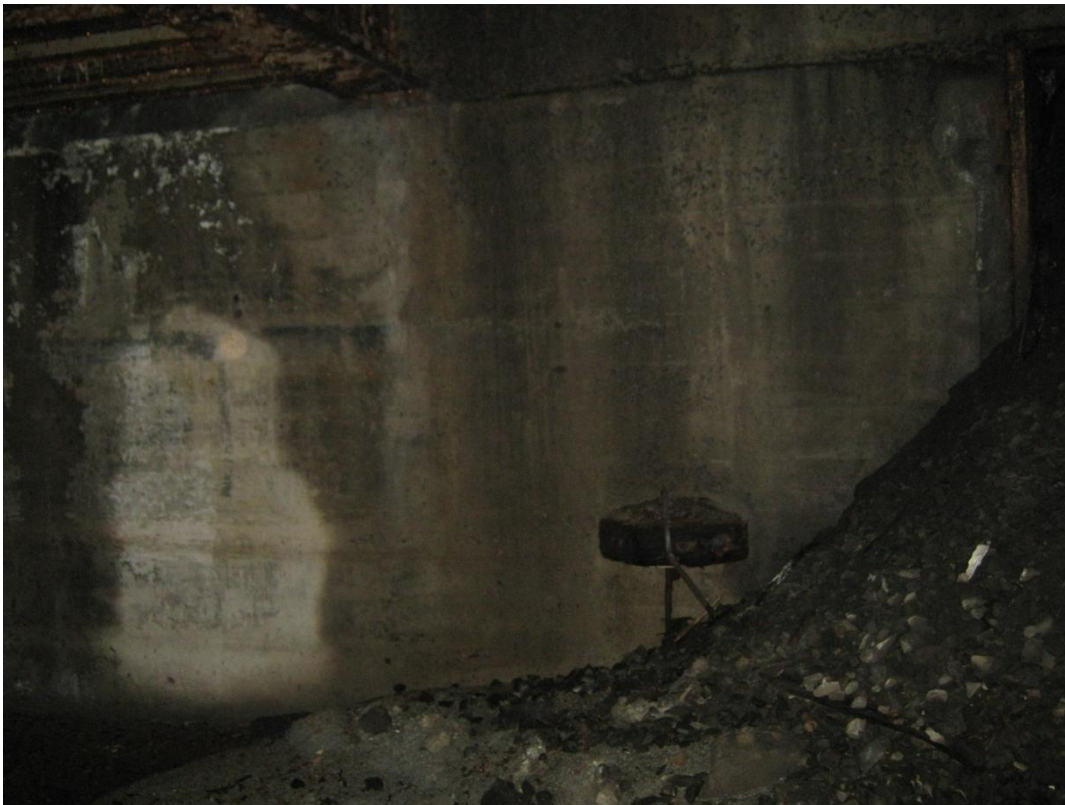
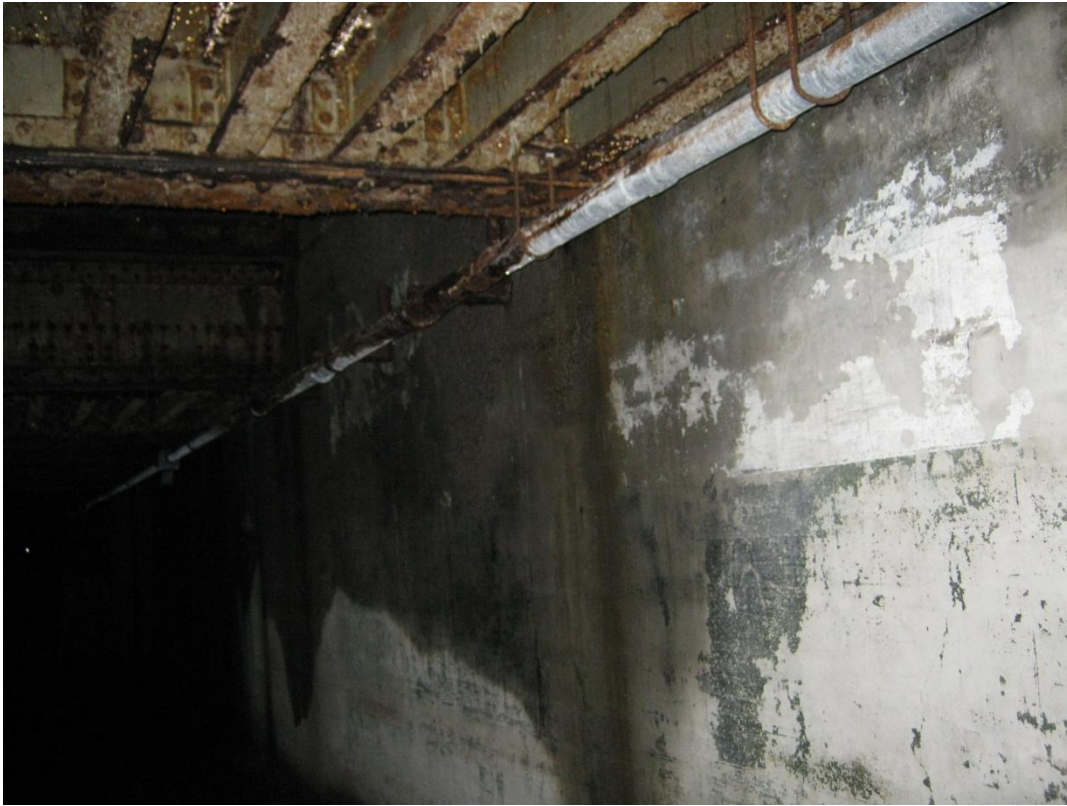
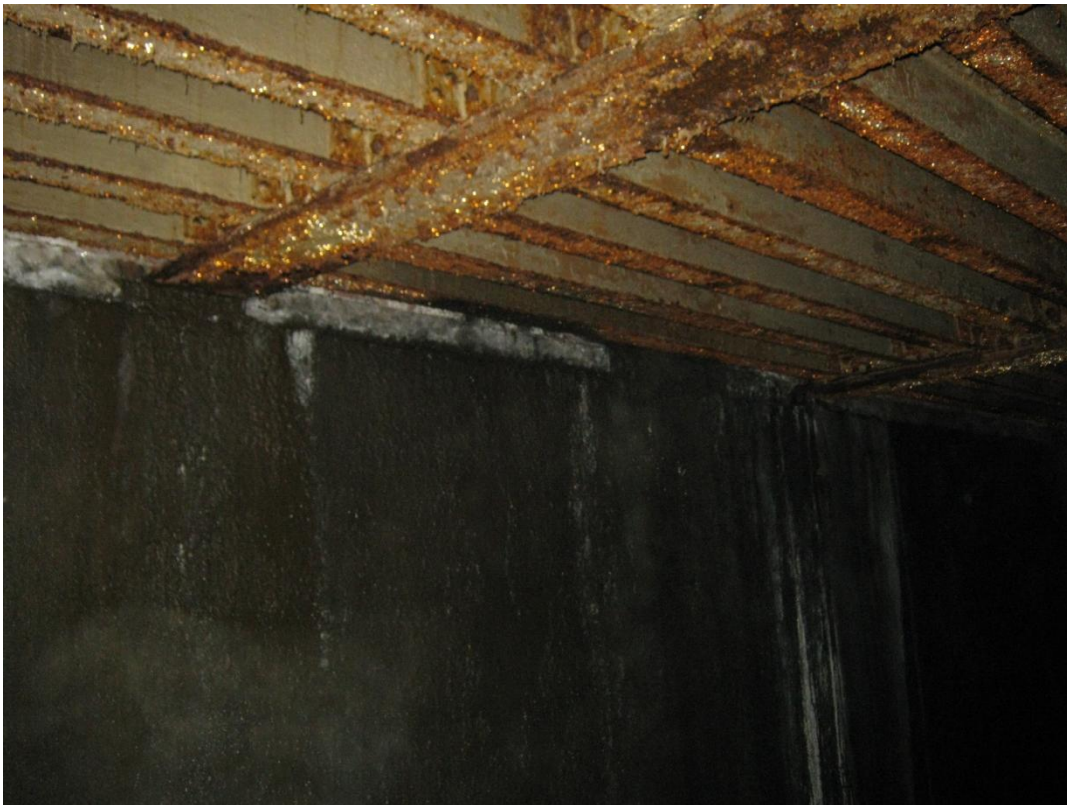
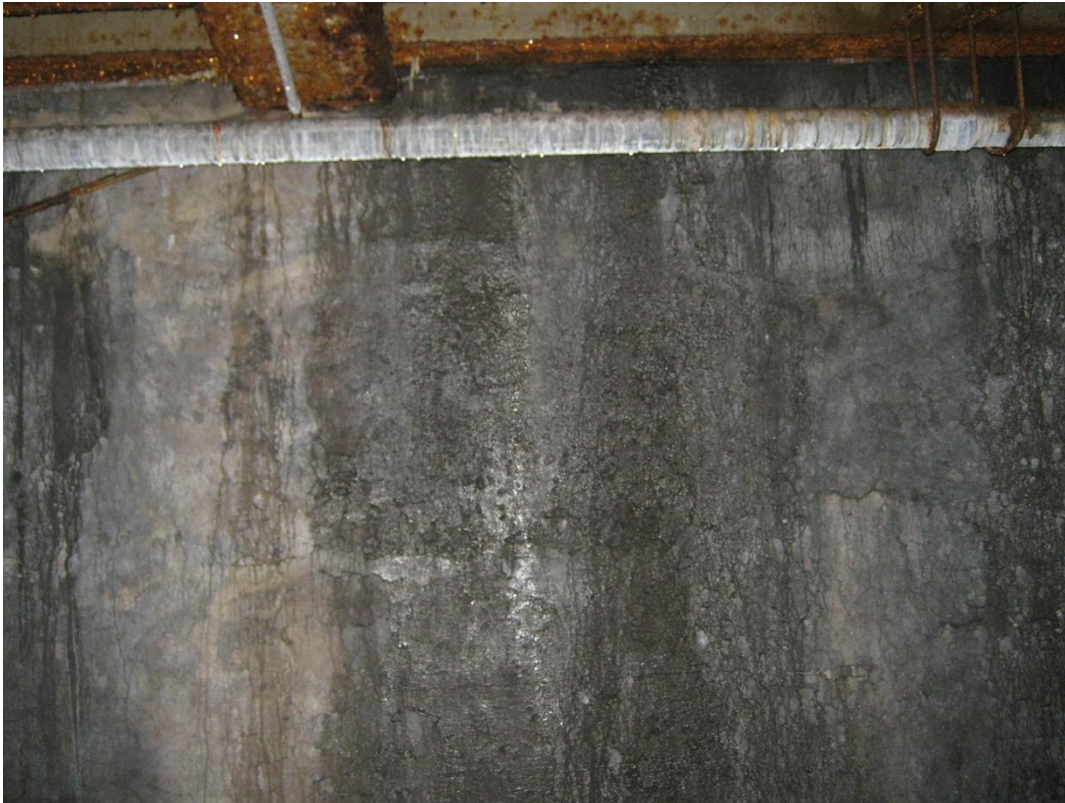
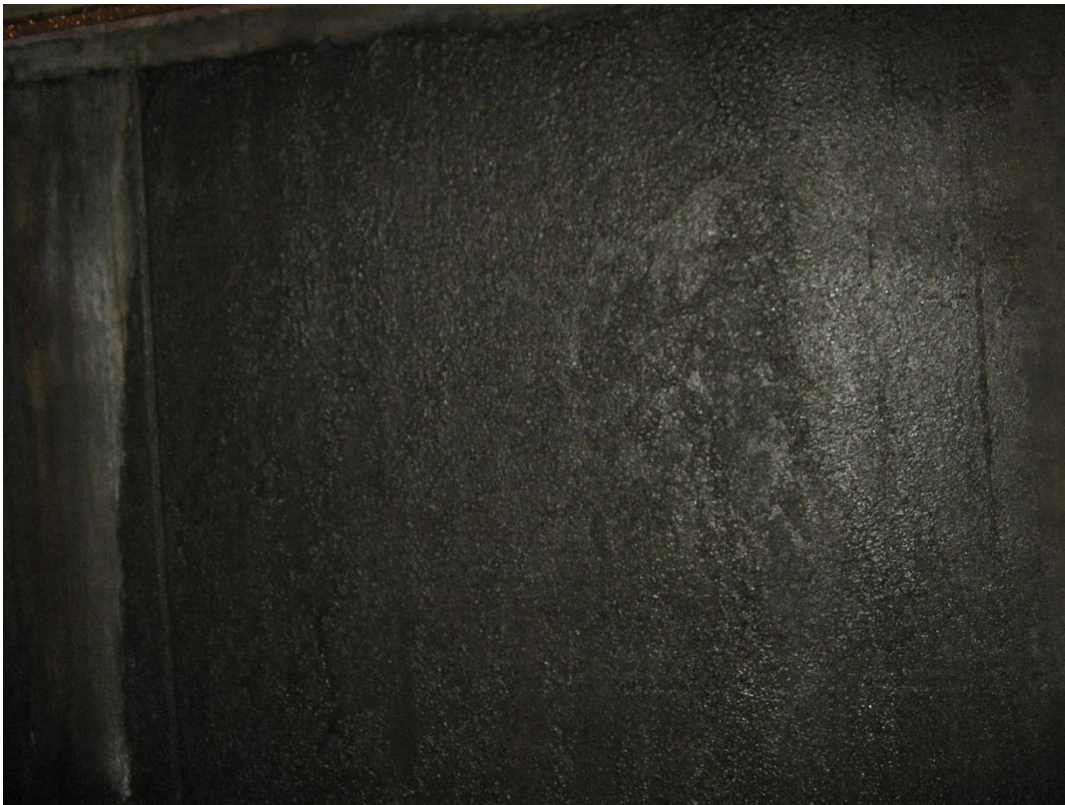
The concrete tunnel walls are generally in fair condition with minor deterioration, including minor spalling below the top seat at isolated locations and surface erosion in localized areas. Active leakage from the roof system and backwall is apparent along its full length, most significant near the southeast end of the tunnel where the overburden

fill appears to be seeping in, running down the wall and 4" to 6" of silty soil has accumulated on the tunnel floor adjacent to the east wall (Appendix A: Photos 37-42).

The 1914 passenger and baggage subway tunnels beneath the operating CSX tracks north of the existing Rochester station building are now 98 years old. The construction details and age have led to water infiltration. Repair of the water infiltration could be a significant and costly undertaking since it would involve the temporary relocation of the overlying tracks, removal of ballast and overburden, and reconstruction and resealing of the tunnel roof system. In addition to repair of the tunnel roof system, various repairs to the structural members within the tunnels to repair cracks, spalls and deteriorated structural steel would also be required.

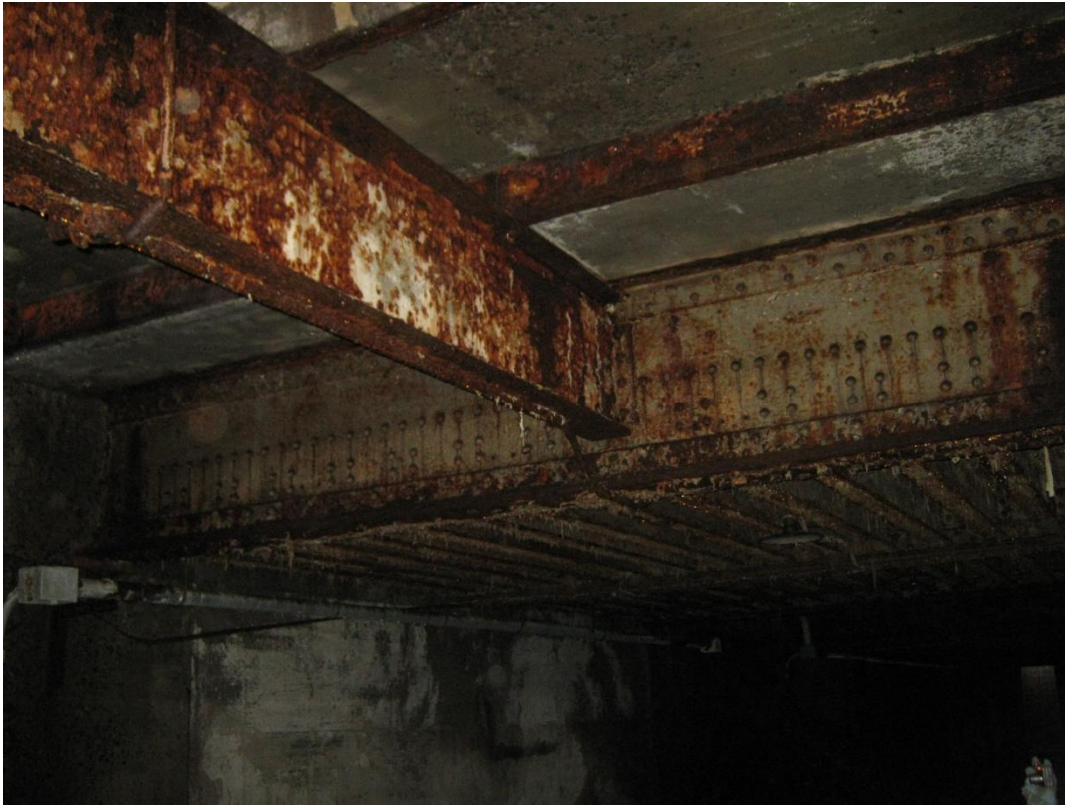
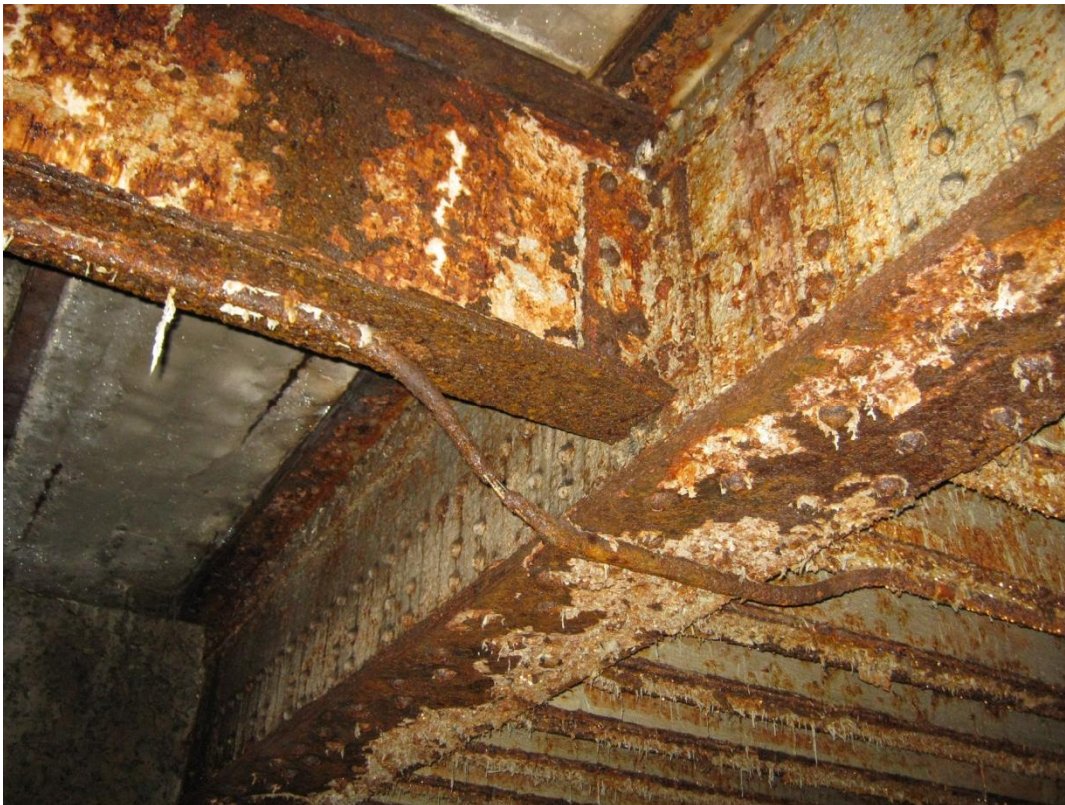
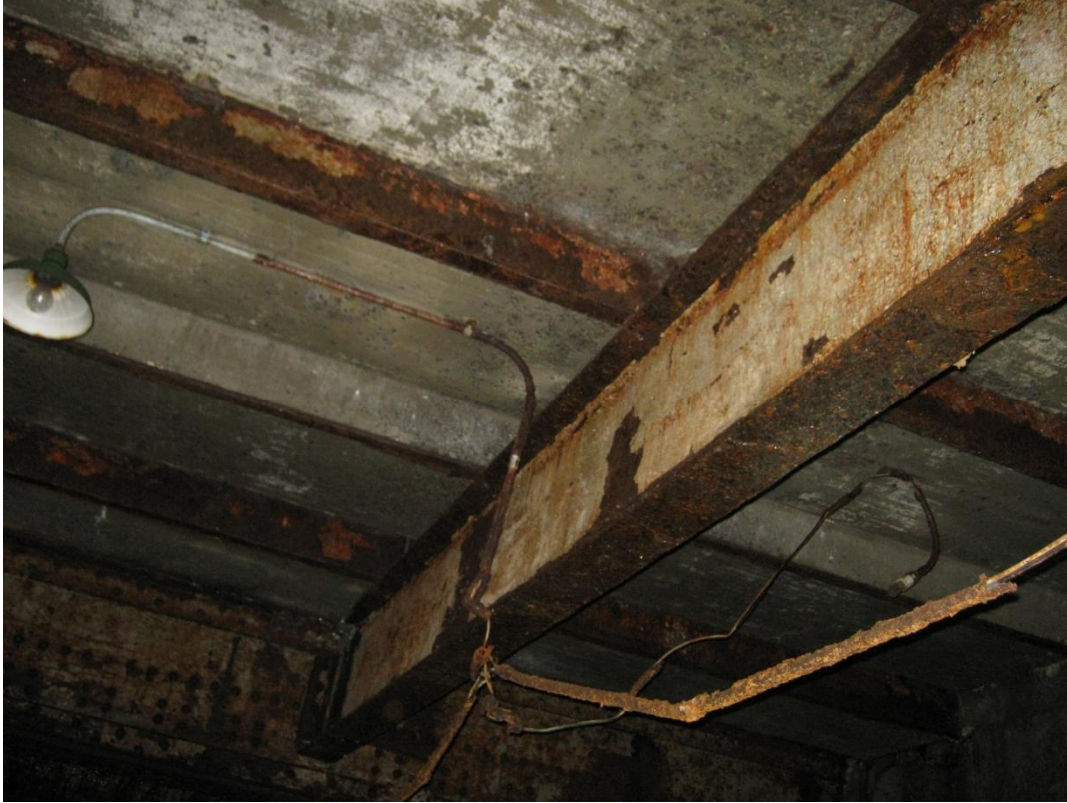
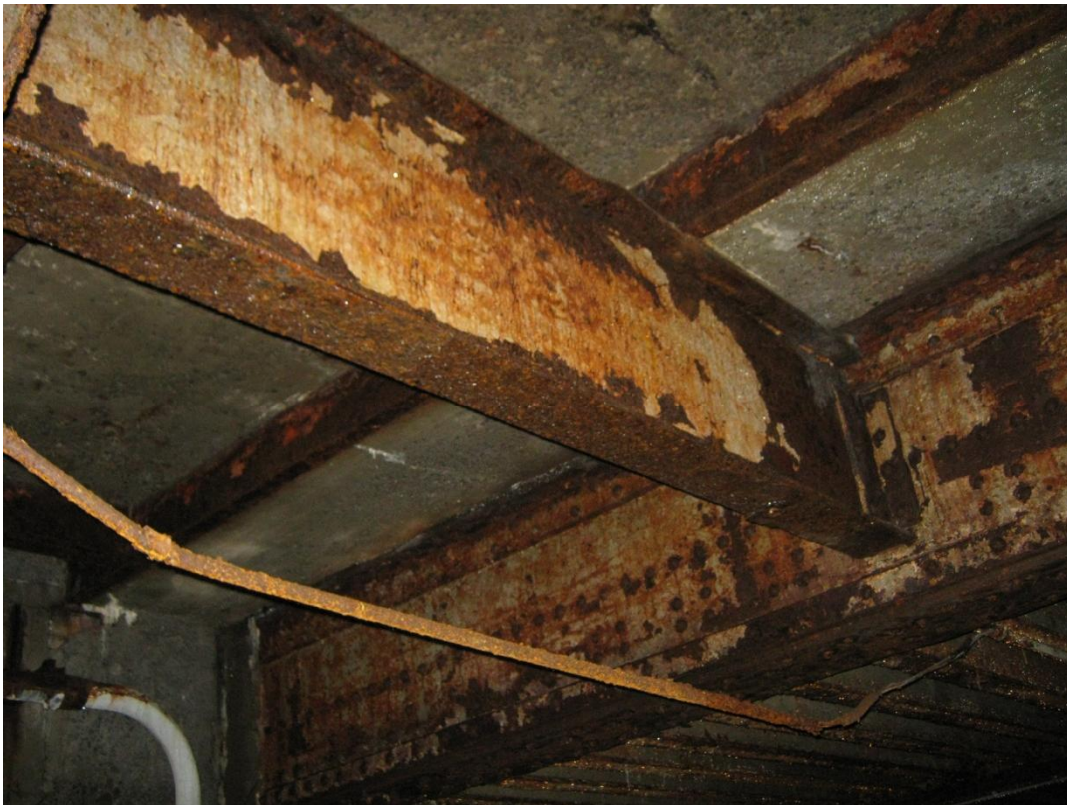
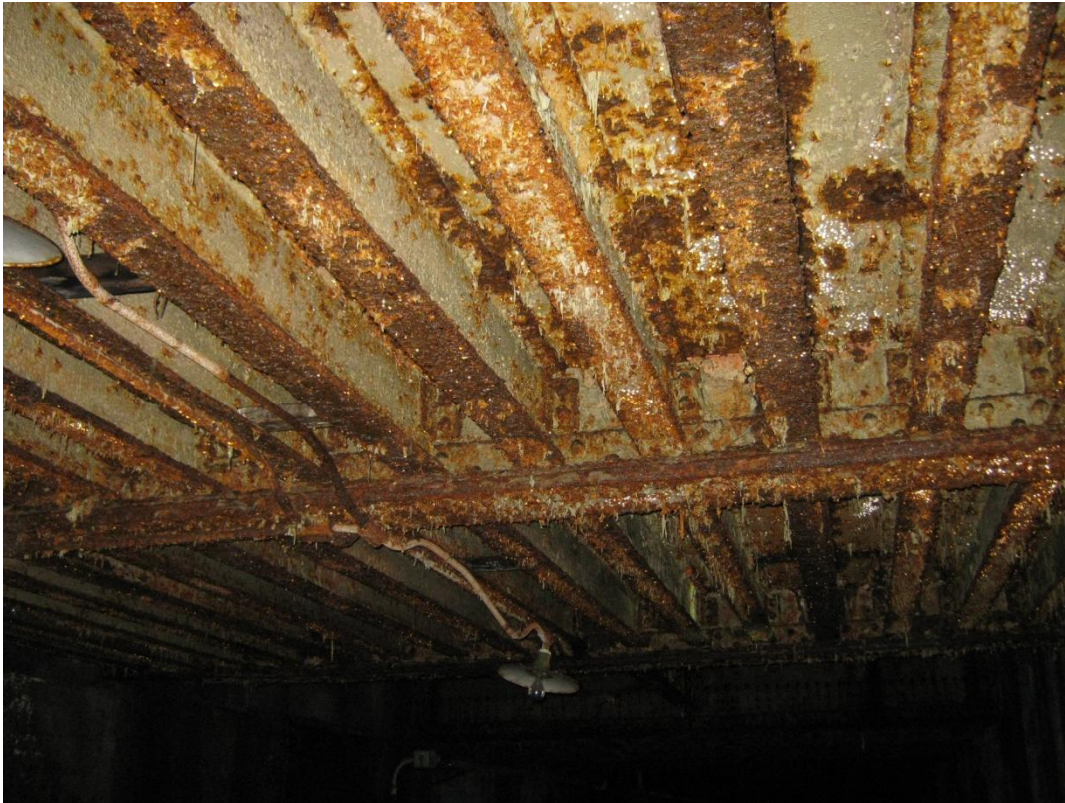
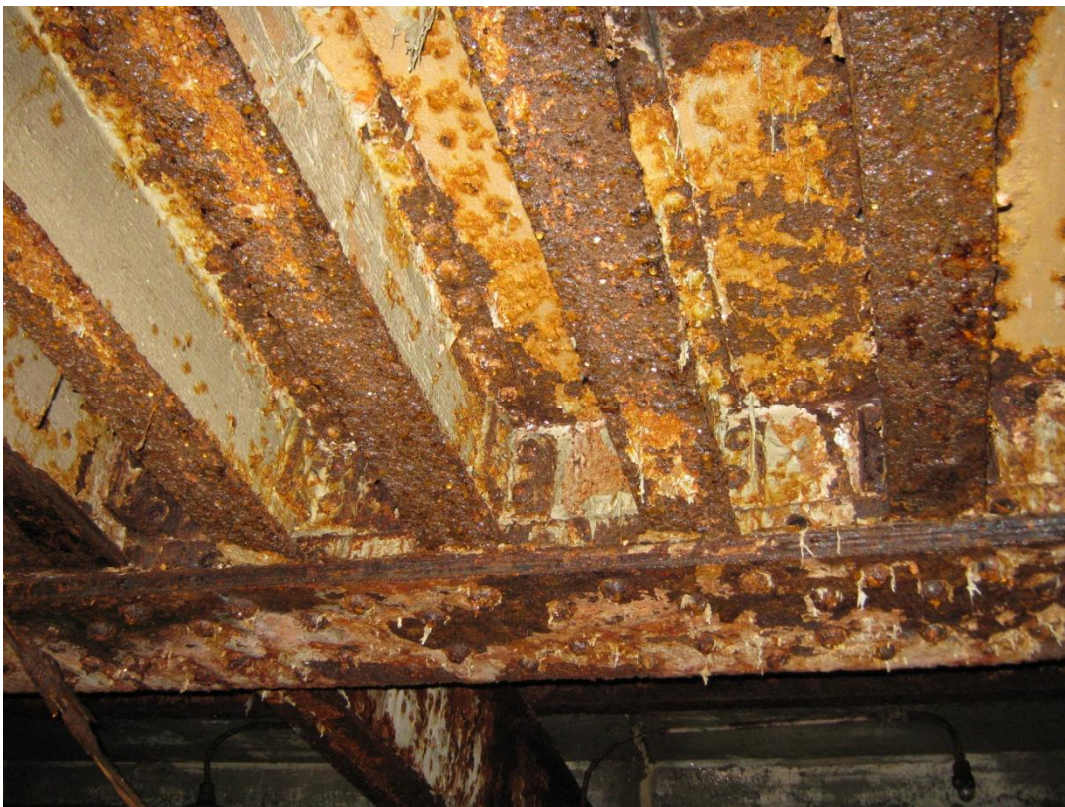
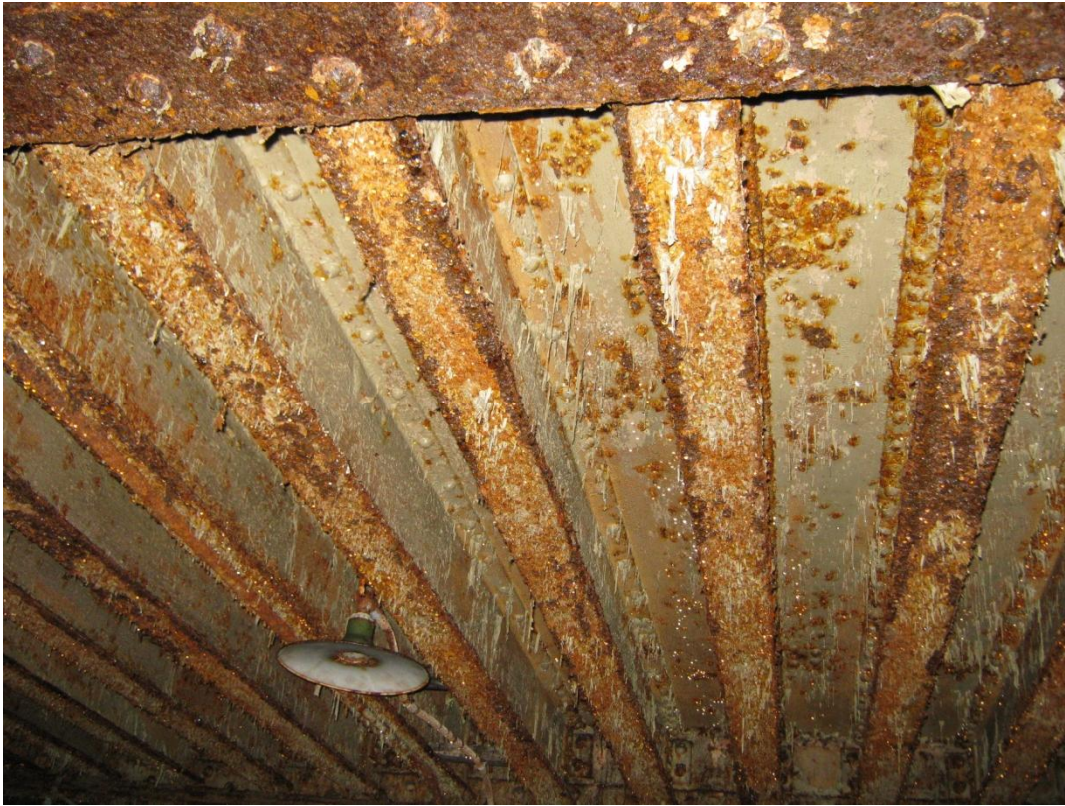
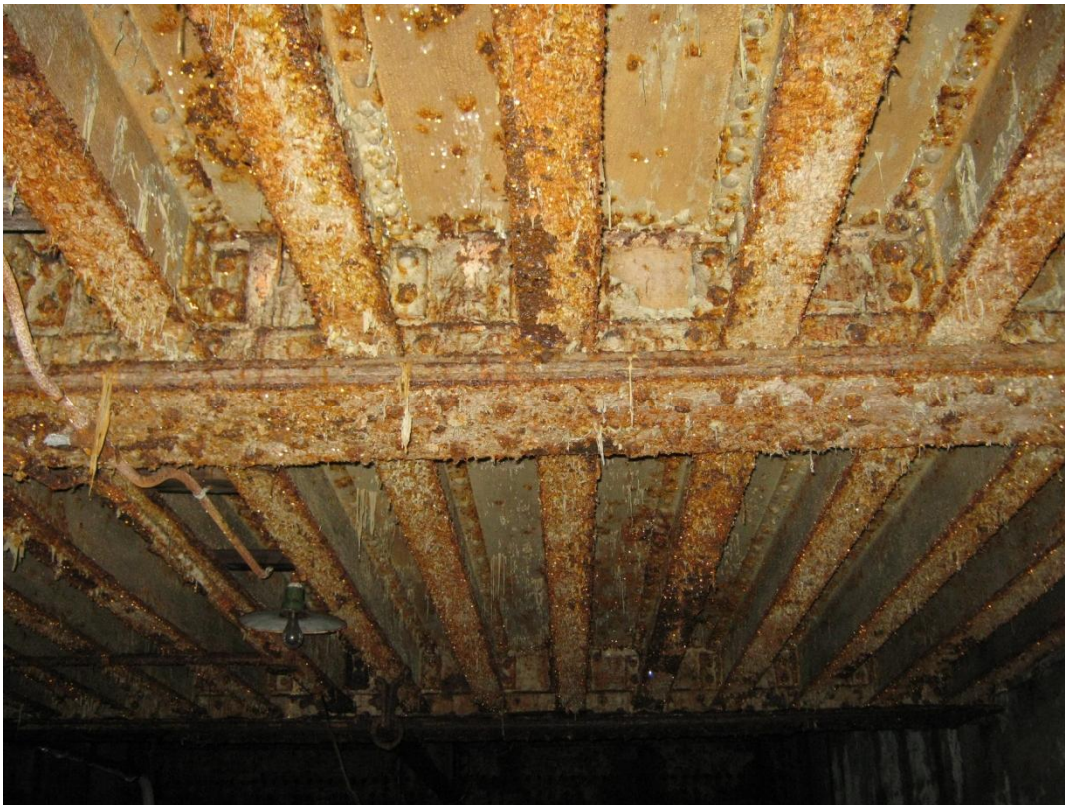
The roof system of the baggage tunnel below the platforms is in fair condition with minor deterioration. Typical deterioration consists of minor spalling of the underside of the concrete roof slab with exposed reinforcing bars, minor shrinkage cracking with efflorescence staining, and some minor active leakage causing a damp surface. The supporting structural steel is generally in poor to fair condition with 100% paint system failure and moderate to heavy rust. Active corrosion is apparent with less than 15% section loss estimated throughout (Appendix A: Photos 43-46). The roof system and supporting structure of the baggage tunnel below the tracks is also generally in poor to fair condition with 100% paint system failure and moderate to heavy rust. The steel barrier plate of the roof system has moderate pitting corrosion scattered throughout causing leakage and efflorescence staining on the supporting structural steel. The efflorescence of the above mortar is evidence that the waterproof membrane of the roof system has deteriorated. Section loss to the supporting structural steel below the tracks is estimated at less than 20% throughout (Appendix A: Photos 47-50). The roof structure of the baggage subway tunnel shows no apparent evidence of fatigue or displacement due to heavy loading associated with the roof dead loads and railway traffic.
